**SAS Superstructure**

Daily Diary Report by Bid Item

Contract No.: 04-0120F4

**04-0120F4
04-SF-80-13.2/13.9
Self-Anchored
Suspension Bridge****Weather**

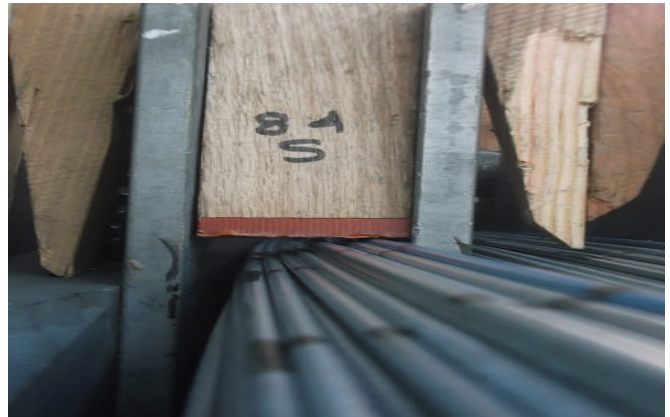
Strand84SouthAfterAdjustment (2)

No one was on the wood block at all and as a consequence, the strand completely lost its nice rectangular, flat top shape out of the saddle. I told Andre about this incident and more than likely he relayed that message to D. Meche (as I am not interacting with Dave) for he came over to take a look at this strand. The funny thing is that there is a pointed wood block in the adjacent trough. It must have been driven to maintain a reasonable spacing between the divider plates; otherwise, it is not doing a bit of good for maintaining the strand in an acceptable shape. The bottom line is that no one here at the Tower from the ABF work force cares about this issue, and if they do (e. g. Andre, they do not have the power to implement.)

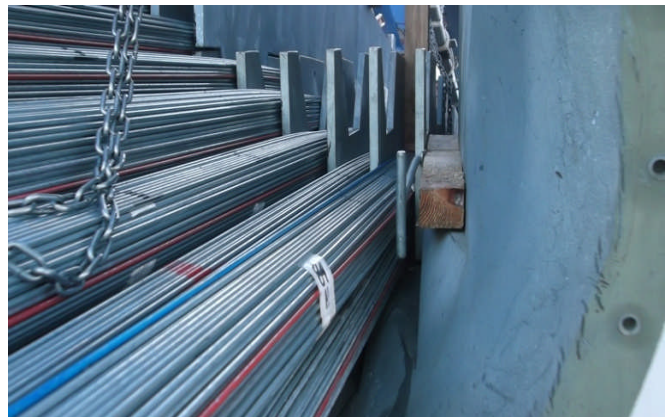
Strand84NorthAfterAdjustmentandadjacenttroughs2

In a very familiar scene, there was no body tending to the wood block here. Tony did call for someone to come over, but he starts the adjusting, regardless. As a result and similar to the South side, this strand experienced a severe banking as well as can be seen in the attached photos. Brian Boal was present at the site during the RA of Strand #84 North and South and took note of the events that took place.

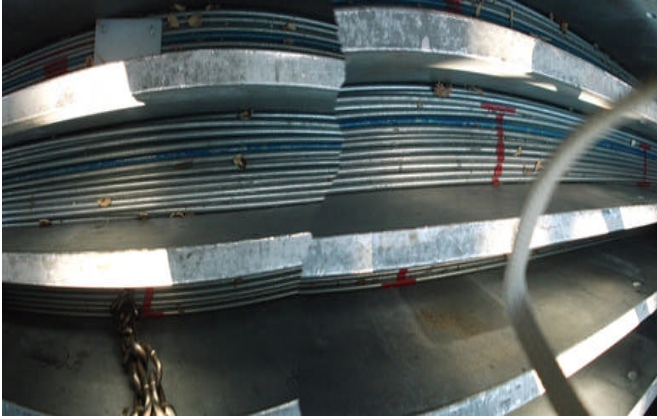
Strand83South (1)

- Inspection of Strand #83South: I did this inspection with Victor@ about 10:00. The attached photos show the status of the strand at locations where the trough widens to widths of about 65mm;
